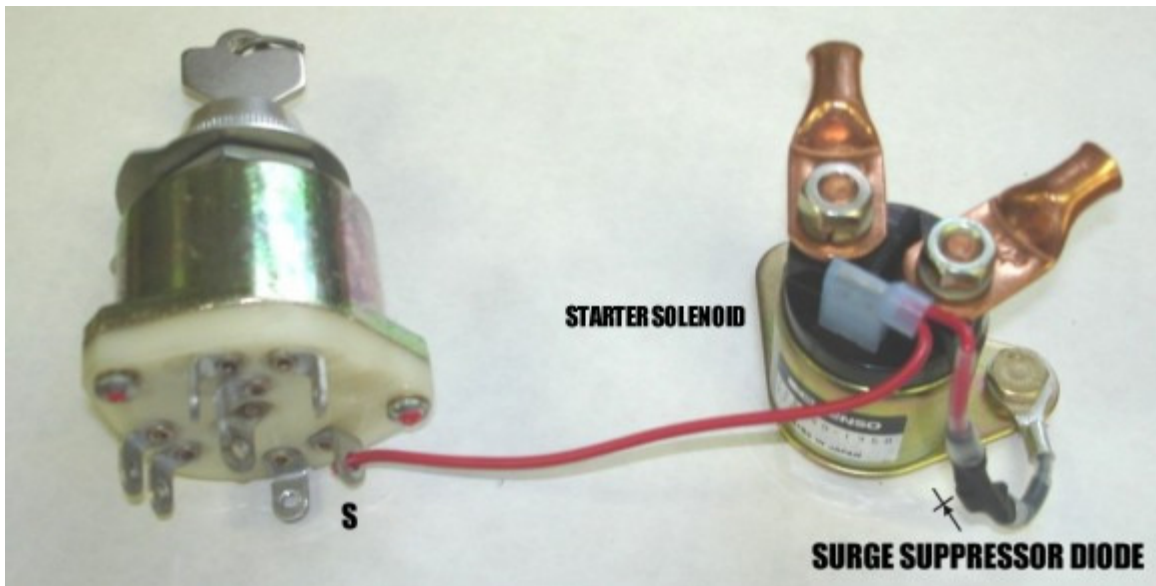
This strobe driver was found to have one or more blown Integrated Circuit chips on its circuit card. The cause for this type of failure is a high voltage spike from the aircraft electrical system. These spikes can be caused by several things, but the most probable is the collapsing magnetic field of the engine starter solenoid. They are easily eliminated with the addition of a “SURGE SUPPRESSOR DIODE” installed on the solenoid. These diodes are often supplied by the starter switch supplier along with installation instructions. They are also available from any electrical parts supply house. A small diode (with a part number 1N4002 or larger) should work just fine.

If you have any doubts that one is installed on your aircraft, refer to the above photo. Find the starter solenoid on your aircraft. It is usually mounted near the engine. It will have the two heavy cables attached, one from the BATTERY and one from the ENGINE STARTER. On that solenoid is a third terminal, this is the POSITIVE ACTIVATION or “S” lead from the starter switch. There should be a diode connected between GROUND and the “S” connection. It must be wired in the direction shown.

The installation of the Surge Suppression Diode should prevent damage to your expensive electrical equipment that is turned on when starting the aircraft engine.
